Presenting
THE PROPERTY INSPECTORS
Pre-purchase Property Report

1 Sample Street
Auckland

RE: Pre Purchase Inspection: 1 Sample Street, Auckland.

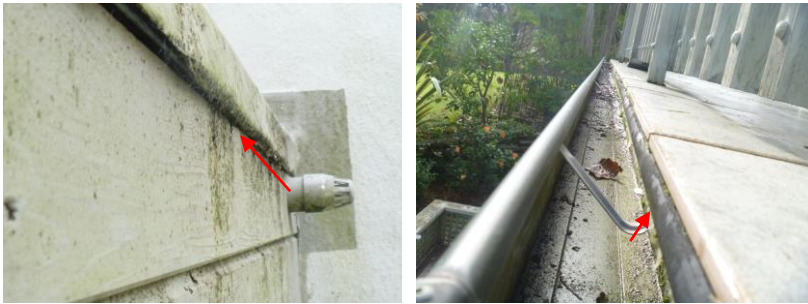
There was no Drip Edge to the Roof above the Gutter, example photos

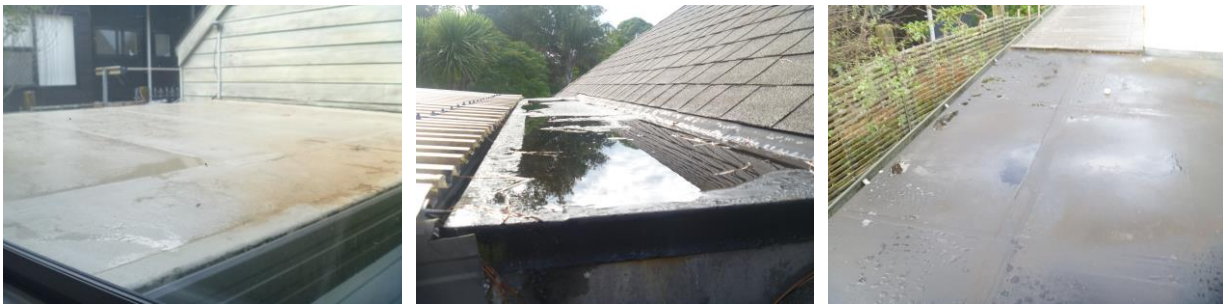
Evidence of ponding Noted to areas of the Flat Roofs due to having low fall, example photos

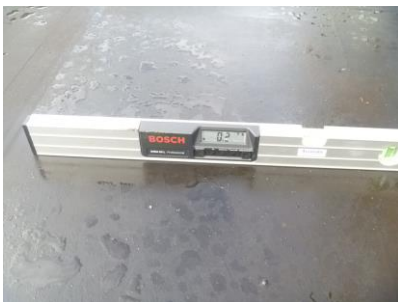
The Flat Roofs were noted to have less than 1 degree of fall, example photo

The current Building Code requires Flat Roofs to have a minimum fall of 2.0 degrees

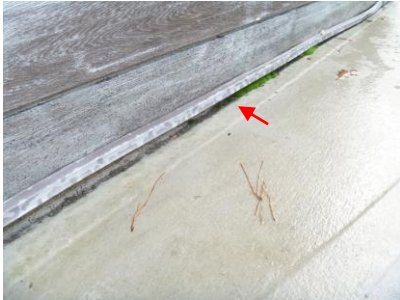
There was no Capillary Break between the Roof and the Base of the a cladding, example photo

The Current Building Code requires a minimum gap of 35mm

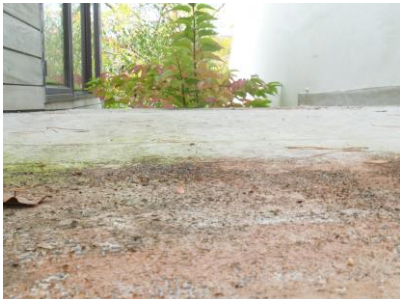
The Surface of the Flat Roof above the Ground Floor Bathroom noted to have age related wear and will require maintenance or to be replaced

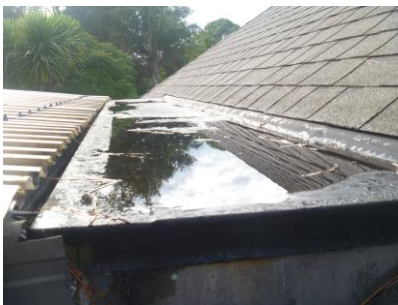
The Roof over the Bedroom was flat, ponding of Water noted

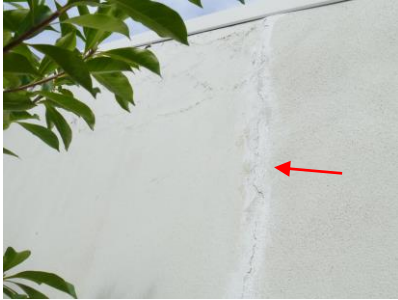
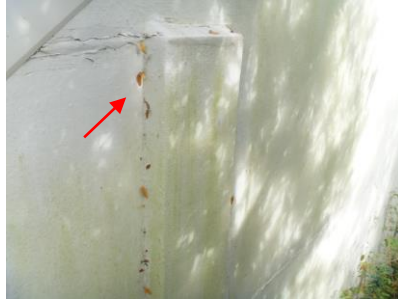
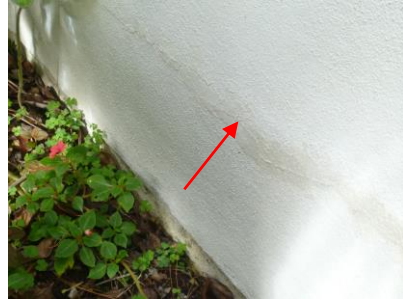
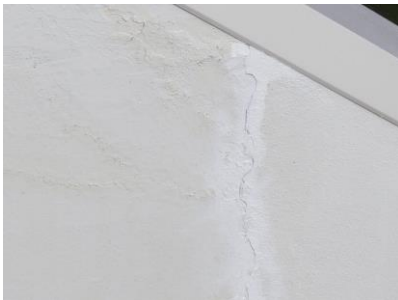
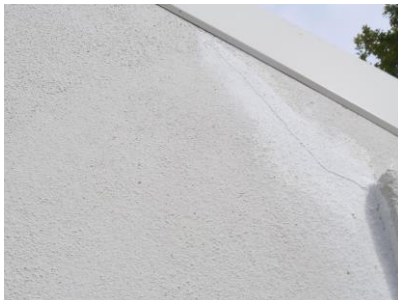
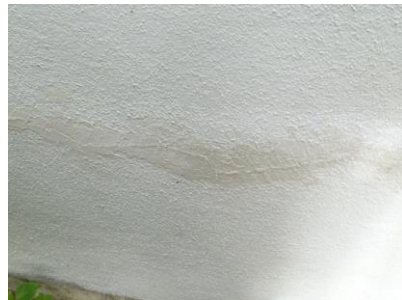
Many cracks noted to the Surface of this Fire Wall

The Writer was unable to comment of the Walls Construction Materials or to the Condition of the Wall behind the Cracked Cladding, example photos

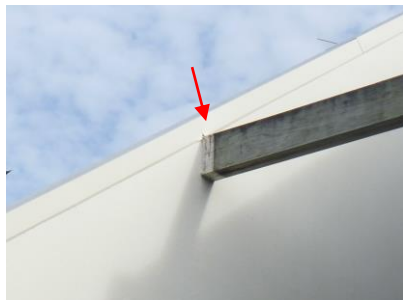
No Apparent Saddle Flashings

At Beam Firewall Junctions, example photo

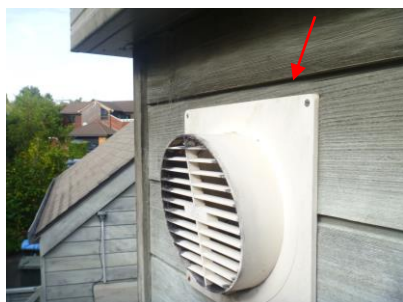
No Mechanical Head Flashings

Above Vent Grilles, example photo

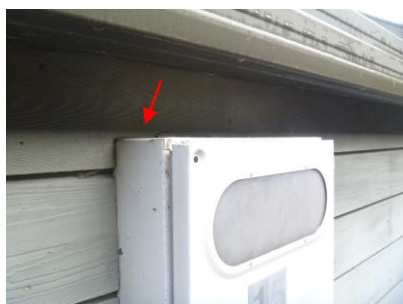
To Exterior Electrical Box as is now required

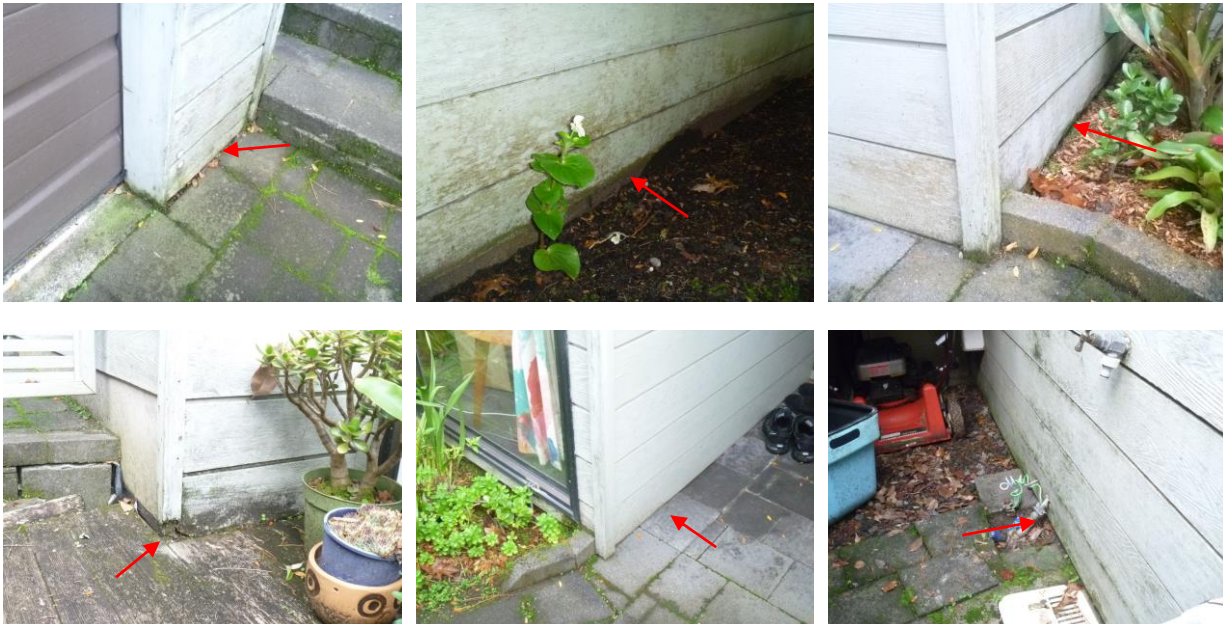
Moisture damage noted to some Weatherboards in close contact or buried below Ground Level, example photos

Recommends Ground Clearances be 175mm above Ground Level, 100mm above Hard Surfaces. This may be reduced to 85mm to 50mm above the Surface of elevated, well Drained Decks or Patios. Damage to Buildings and Structural Frame and Internal Dampness are often the result of Moisture being sucked up from the Ground by Capillary Action behind Cladding. Under no circumstances should Cladding be carried down to Ground Level. Recommended that all areas be checked to ensure this clearance is observed

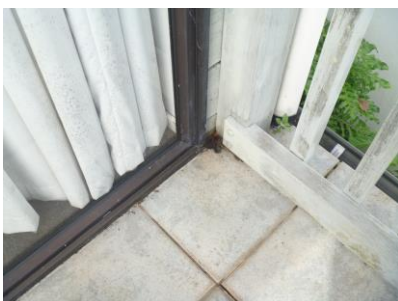
Moisture damage noted to some Weatherboards in close contact with the Balcony Deck, example photo

Note the lack of threshold between the Exterior & Interior Levels

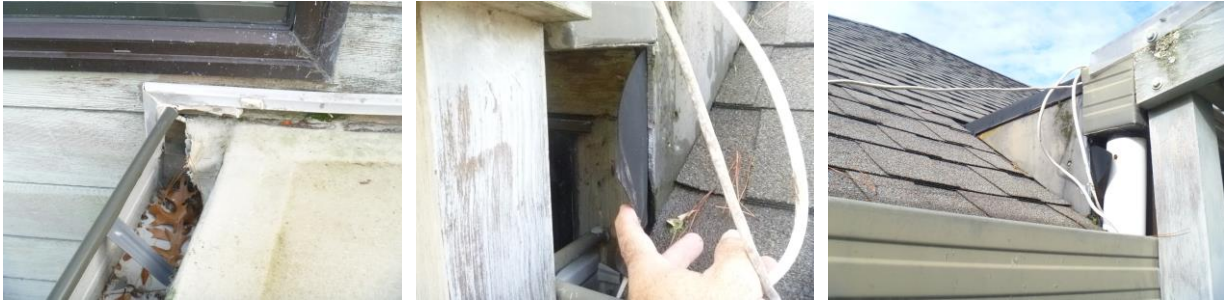
These are difficult areas to flash and to prevent Water Ingress, example photos

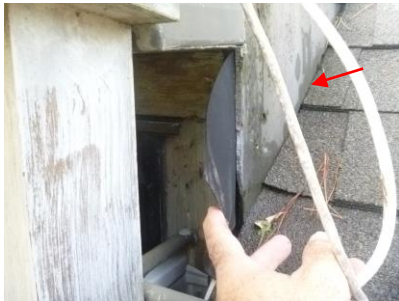
Insufficient Clearance and Capillary Breaks at the Base of Cladding with Roof Apron Flashings

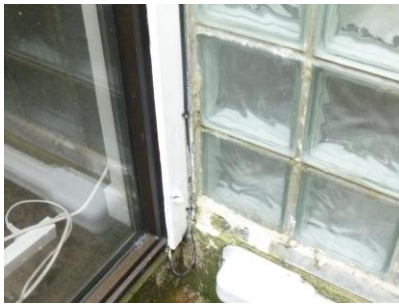
Cracked Bricks noted in Ground Floor Bathroom Shower

Sealant noted to have been used to several Glass Brick Joins

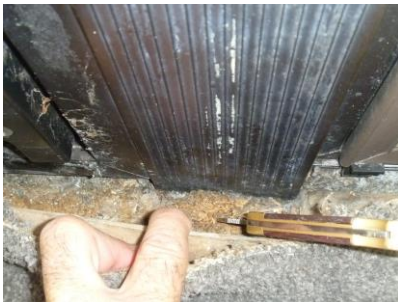
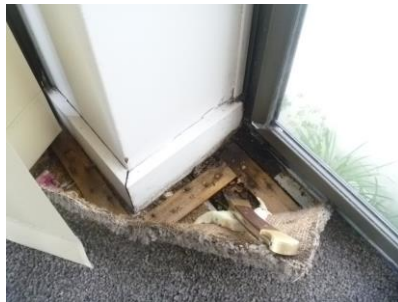
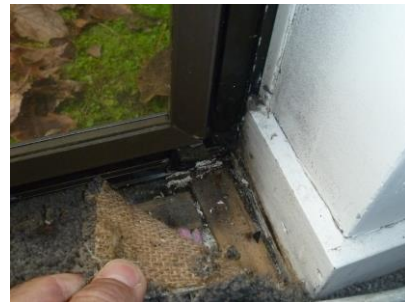
Water Ingress and Moisture damage was noted to Flooring and surrounding Timbers at Joinery at Wall Junctions, example photos

Concrete
Composite Board
Over Floor Joists
Moisture damage noted
Too many areas of Flooring, refer Window Section for example photos

Further investigation is recommended to establish the extent of damage caused

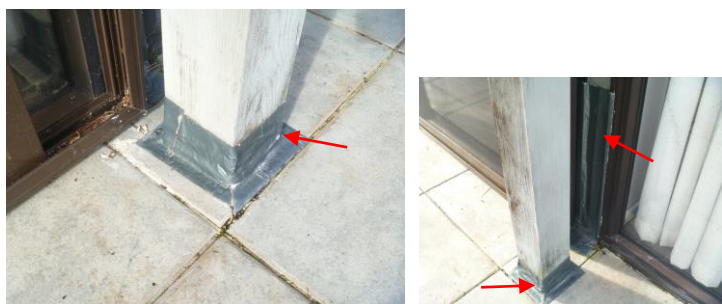
The Wall/Balcony Junction appeared to have been poorly installed; repairs were noted to have been carried out to several areas, example photos

Balconies with Membranes are well documented areas of water Ingress if not installed and sealed correctly

Secured through the Balcony Membrane, repairs noted to have been carried out, refer photos above

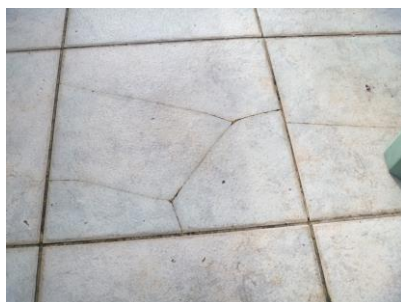
Several cracked Tiles noted, example photo

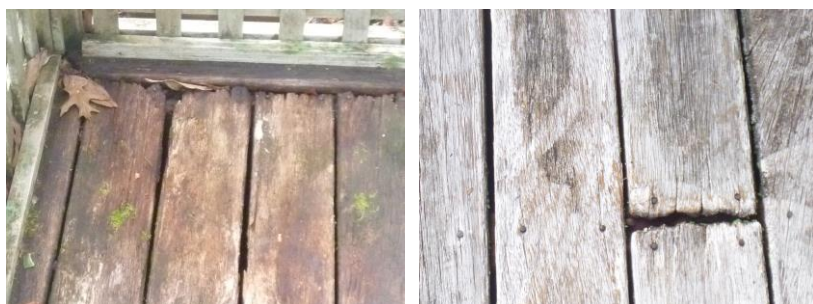
Decks
Timber
Age related moisture damage noted too Decking, example photos

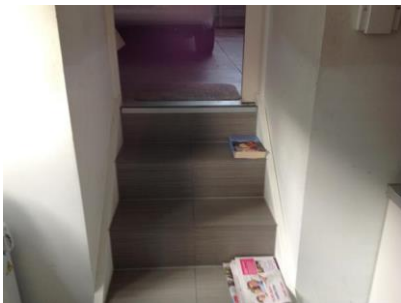
Handrails
Generally appeared reasonable
No Hand Rail to Stairs leading to Garage

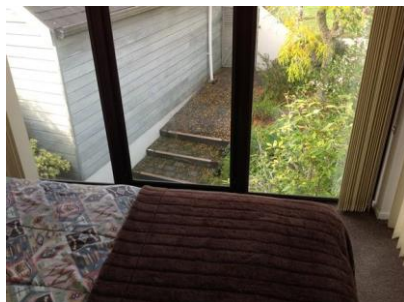
The use of Non Safety Glass to Low Windows may have been acceptable at the time of construction

The current Building Code would require Safety Glass to be fitted, example photo

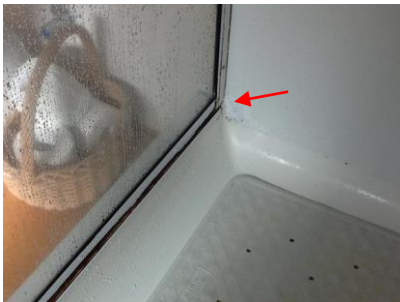
Formica Wall Liners, damage noted to Wall Liner

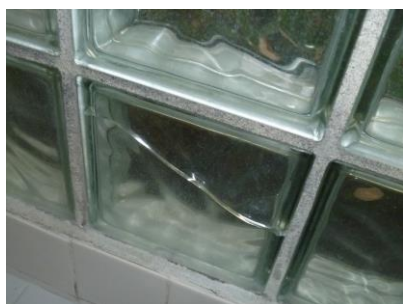
Cracked Glass Brick noted

Grout and Cracked Tiles require to be replaced to several areas

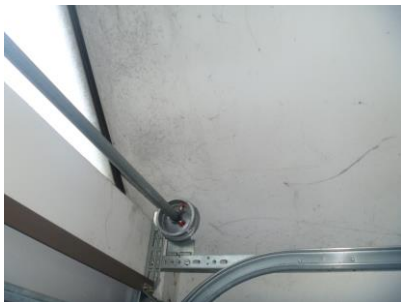
Evidence of Moisture & Mould

Noted to Garage Ceiling, example photo

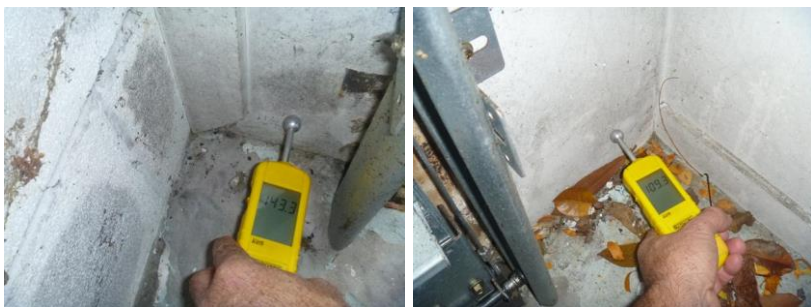
Raised moisture readings

To Garage Wall Lining beside Garage Door

Recommend further investigation or intrusive testing to establish the apparent cause to areas where elevated moisture readings were recorded and to establish if there is any moisture damage to surrounding Timbers

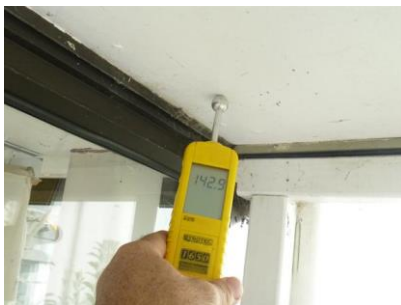
Found to Soffit under Balcony Deck, 142 units, refer Moisture Section at rear of Report

To Soffit below Balcony near Lounge
